Safety Notice – Voluntary Product Recall

Product	Item number	Lot number
Support Ring, height 10 mm	15-8502/66	1249055
		1249056
		1230047

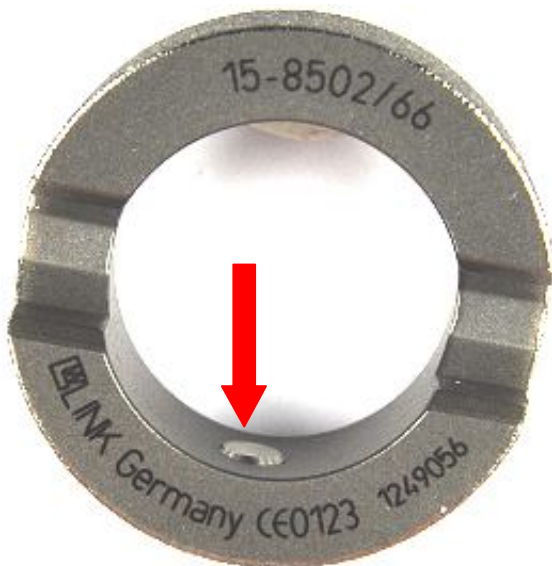
Figure 1: Support ring affected by the FSCA

The affected support rings could not be placed over the stem with a diameter up to 18 mm. The reason is that the set screw was screwed too far into the inner diameter of the ring. Due to a press-thread it is not possible to screw the screw out of the ring.

The figure shows the inner diameter of the support ring with a protruding set screw with blunt tip (red arrow).

Recall and replacement of the affected support rings.
