30.11.2017

URGENT PRODUCT SAFETY INFORMATION / PRODUCT RECALL

2M insert 15° for MUTARS® RS cup and LUMiC® TiN

Our Reference No.: FSCA_17002

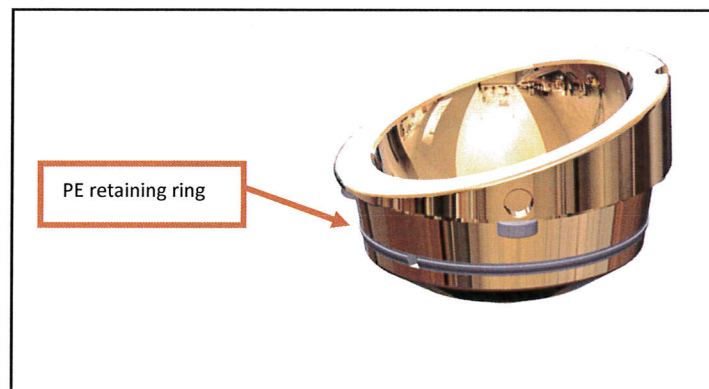
Figure 1: 2M Inlay 15 ° with PE retaining ring

Figure 1 shows a 2M Inlay 15 ° with PE retaining ring.

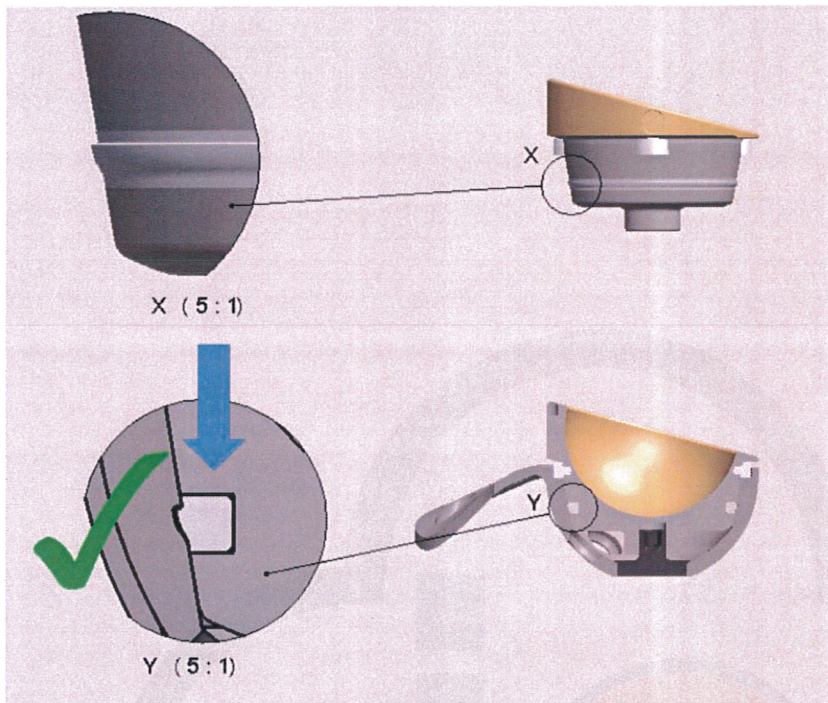
Figure 2:

The PE retaining ring has a top and a bottom side to it. If the ring is mounted correctly, a snap-on lip snaps into a notch in the hip cup to ensure correct and secure positioning of the inlay in the hip cup (see Fig. 2).

Correct mounting:

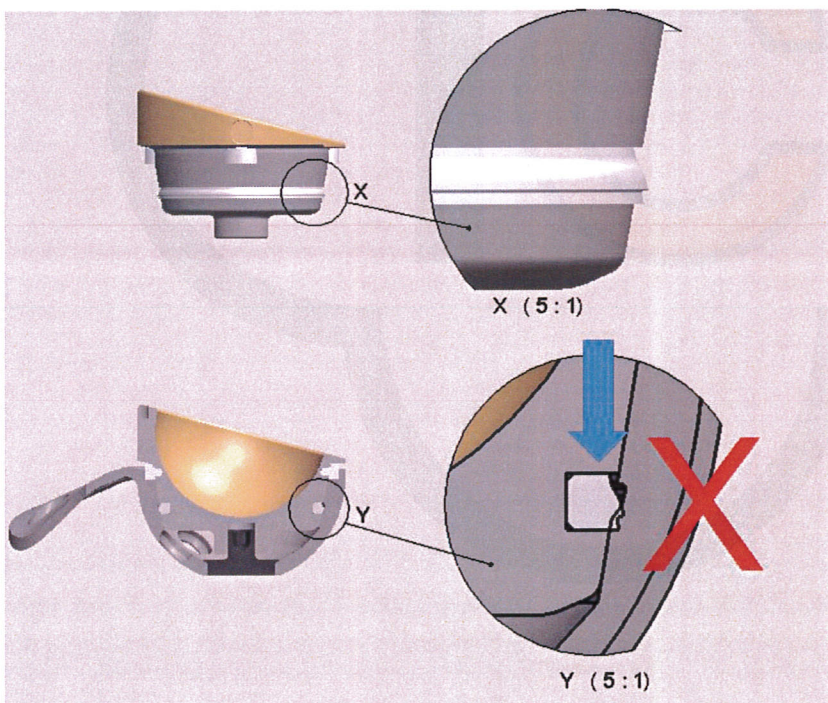
Figure 3:

During a user training with sterile packaged original parts, it came to light that the retaining ring in a 2M inlay 15 ° for MUTARS® RS Cup and LUMiC® TiN Ø 38/39 mm had been incorrectly mounted into the groove of the inlay. It cannot be ruled out that this assembly error has also occurred with other sizes.

If the retaining ring is mounted the inside out, the snap-on lip cannot offer a positive lock but will be squashed and the retaining ring cannot fulfill its function (see Fig. 3).

Wrong mounting

The upper part of the figure shows the snap-on lip of the 2M Inlay 15° mounted the wrong way round, zoomed in on the right. The nib of the latch lip points downwards.

The lower part of the figure shows the incorrect fit of the inlay in a hip cup (left). The enlargement of the detail shows the latch lip pointing downwards (right). This alignment no longer offers the originally intended safety function.

Improper mounting will not guarantee the correct and secure positioning of the 2M inlay in the hip cup.

1. With immediate effect all 2M insert 15° you might have on stock may no longer be implanted.
2. We are recalling all concerned implant components of the REF-numbers listed above for inspection by us.
3. Please fill in the attached fax-form and return the fax to implantcast within five working days.
FAX: +49 4161 744 201
