Doc. Ref. FSN201801

Urgent: Field Safety Notice ref. FSCA201801

Subject: DOUBLE ROW FOOTPLATES, TL-HEX STERILE, ALL SIZES. Below is reported the list of codes and batches involved.

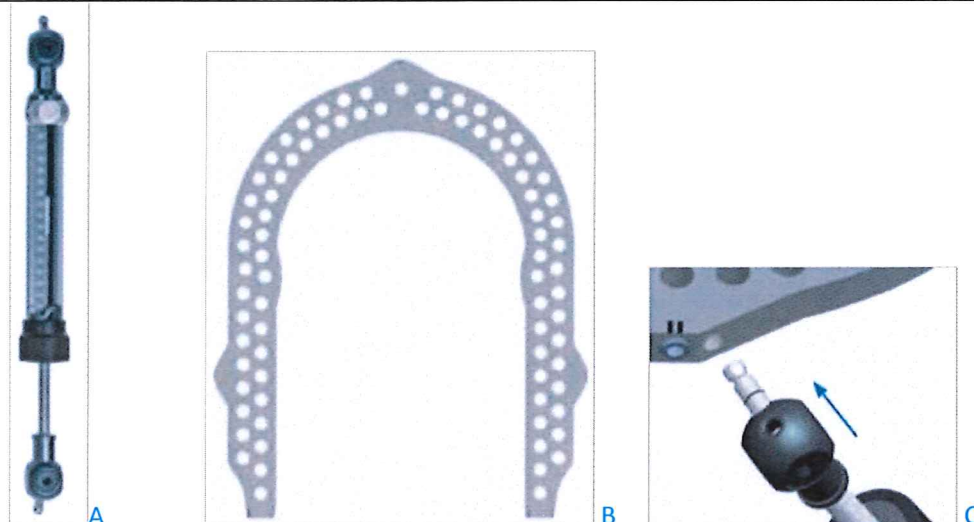
Details of the FSCA			
Date		January 23, 2018	
Reference Contact		Orthofix Srl Customer Service department Orthofix Srl Via delle Nazioni, 9 - 37012 Bussolengo (Verona) Italy e-mail: customerservice@orthofix.it – tel. +39 045 6719000 – fax. +39 045 6719380	
Affected Products	Product code	Batch number	Product Description
	99-56-22000	V1374370	DOUBLE ROW FOOTPLATE, 120MM, TL-HEX STERILE
	99-56-22020	V1374298	DOUBLE ROW FOOTPLATE, 140MM, TL-HEX STERILE
	99-56-22040	V1374255	DOUBLE ROW FOOTPLATE, 160MM, TL-HEX STERILE
	99-56-22040	V1374374	DOUBLE ROW FOOTPLATE, 160MM, TL-HEX STERILE
	99-56-22040	R1065030	DOUBLE ROW FOOTPLATE, 160MM, TL-HEX STERILE
	99-56-22060	V1374259	DOUBLE ROW FOOTPLATE, 180MM, TL-HEX STERILE
	99-56-22080	V1374361	DOUBLE ROW FOOTPLATE, 200MM, TL-HEX STERILE
	99-56-22100	V1374373	DOUBLE ROW FOOTPLATE, 220MM, TL-HEX STERILE
Details of the FSCA		<p>As of January 19, 2018, Orthofix has received a total of 8 complaints of incompatibility and dimensional interference between double row footplates manufactured in a limited period of the year 2014 and struts manufactured after September 2016. Orthofix Srl conducted an investigation by performing technical analysis, medical evaluations and a review of the risk analysis.</p> <p>The result of the investigation determined that some production batches of double row footplate, manufactured in a limited period of the year 2014, are now potentially not compatible with the current version of the TL-HEX struts.</p> <p>In detail, it is possible that the stud of the strut (picture A) cannot be inserted in the hole of double row footplate (picture B and C).</p>

The reported incompatibility was caused by a design problem for which the combination of tolerances of two parts (double row foot plate – struts) can generate interference with consequent difficulty to insert the stud of the strut in the hole of double row foot plate.

Orthofix determined that all footplates manufactured in a specific period of year 2014 be withdrawn from the market.

Immediately identify the products in Your warehouse which are involved in this action, remove them from inventory and return to Orthofix Srl (see contact details above).

Do not use any products involved in this action and immediately return to your local distributor or directly to Orthofix Srl (see contact details above)
