Urgent Field Safety Notice - FSN20213004-02 Rev 002

Type of Action: Advisory

SynCardia Companion 2 (C2) Driver System (Catalog # 397002-001)

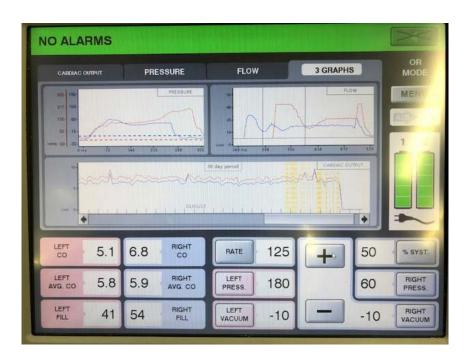
If an asynchronization of valve actuation between the C2 Driver's two pilot valves occurs, it will result in an activation timing difference between the valves. The timing issue will be observed on the C2 Driver Pressure and Flow monitor screens as a separation between the ventricles' systolic waveforms (Pressure Monitor Screen) and diastolic air flows at the beginning of the diastolic fill cycle (Flow

Monitor Screen). See **Figure 1** for an illustration of separated air flow waveforms at the beginning of a diastolic fill cycle.

Figure 1 – A waveform divergence between Pressure (Pressure Monitor Screen) and Air Flow (Flow Monitor Screen)

SynCardia has identified the root causes of the issue to be particulate contamination from the incoming air supply, and/or from the valve not completely closing due to residual electrical drop-off current applied to the valves when they are not activated.

A clinician/physician monitoring a patient on support with a C2 Driver should switch the patient to a backup driver **immediately** after observing:

- 1. A divergence between the Pressure waveforms and the Air Flow waveforms, as illustrated in **Figure 1**
- 2. An unexpected drop in cardiac output for one of the 2 ventricles,
- 3. "Low CO" alarm (Low cardiac Output)
- 4. A right/left cardiac output imbalance alarm.

• We have implemented a shorter change-out maintenance interval for the pilot valves on the Companion C2 Driver Console. Instead of replacing the pilot valves at the two-year service, we replace them at the customary 90 days of use service interval. It is important to note that since the pilot valve replacement at the shorter interval was fully implemented globally in October 2019, we have not received any reports of the issue since that date.
