<p><b>Hillrom™</b> Hillrom Luleå Nedre Vägen 100, 975 92 Luleå, Sweden</p>	<p><b>Field Safety Notice</b></p>	<p><b>FA 2021-010-002-LUL-001</b></p>
--	-----------------------------------	---------------------------------------

**Subject:** Missing bushing on Liko M220 and M230 causing wear and potential for falls.

**Commercial name of affected product:** Liko M220, Liko M230

**Affected Models:** 2050010 & 2050015 manufactured between 2016-DEC-27 and 2021-SEP-01.

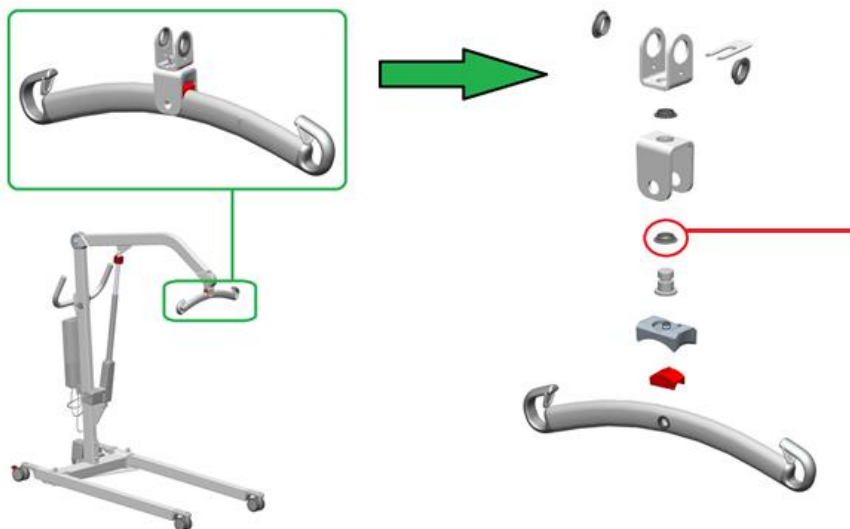
Hillrom has received customer complaints whereby a Slingbar had detached from the upper bracket of the sling bar attachment. Investigations indicated that a bushing was missing on the product. The missing bushing causes wear on the Slingbar attachment, which in turn can potentially cause the sling bar to detach from its attachment. If the slingbar detaches from the upper bracket, this has the potential for patient falls.

*Figure 1: Mechanism and parts included in the sling bar for M220/M230. Bushing marked in red.*

Hillrom investigation determined that the root cause of the slingbar detachment is caused by wearing at the slingbar attachment due to the missing of a plastic bushing (see red markings in Figure 1) as part of the assembly during manufacturing of the device. It was determined that assembly of this device has the potential to not contain this plastic bushing on devices manufactured between 2016-DEC-27 and 2021-SEP-01.

A missing plastic bushing on the device can cause wearing on the slingbar attachment. Over time, this wearing can cause the slingbar to detach from the lift, which may result in a patient fall. Hillrom can confirm there have been no death or serious injuries reported from this failure.

Upon receipt of the response form, identifying potentially impacted devices, Hillrom or an official Hillrom distributor/representative will be in contact to schedule inspection of your device to confirm presence of the bushing. Where it is confirmed that the device is missing the bushing, a replacement slingbar with the bushing will be installed.

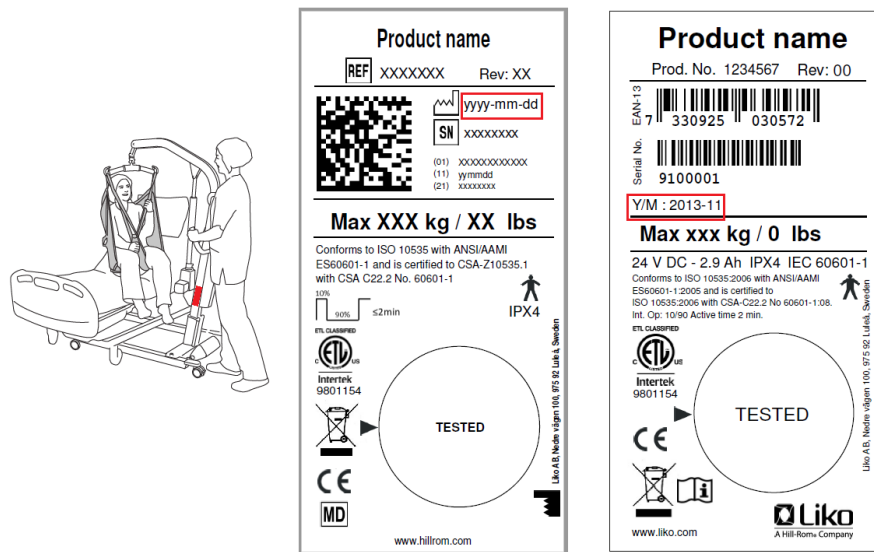
Figure 2: Placement of the label and its designs. Left: New design. Right: Old design.

1. Review the product label on your Liko M220/M230 to determine if it is impacted by this field action by identifying the manufacturing date of the device (i.e. Manufacturing date between 2016-DEC-27 and 2021-SEP-01). See figure 2.
