Field Safety Notice Philips Respironics - Hospital Respiratory Care

V60/V60 Plus/V680 Ventilator 35V Rail – 2021-CC-HRC-003

21 April 2022

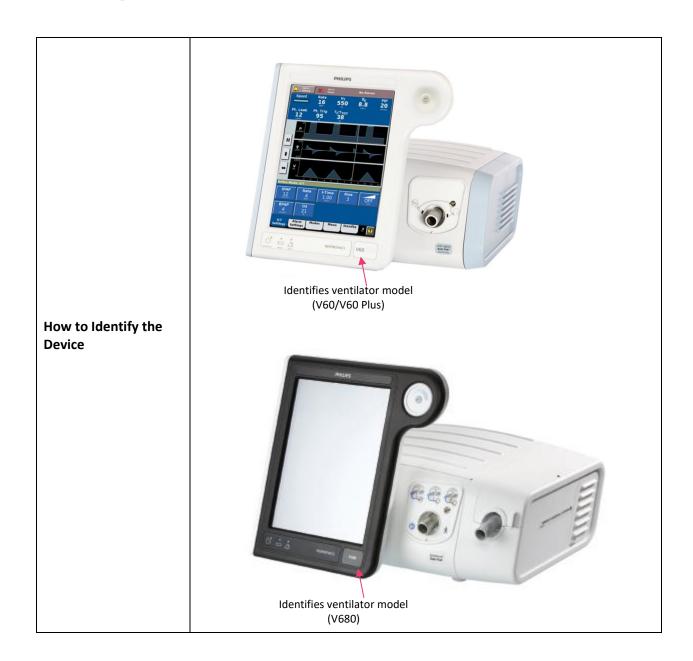
3. Affected products and how to identify them

All V60/V60 Plus ventilators are impacted by this issue regardless of date of manufacture.
