URGENT FIELD SAFETY NOTICE

Tibial Components / Modular Joint Component Units of
Endo-Model – M Modular Knee Prosthesis System

Tibial Components of
Endo-Model SL Rotational and Hinge Knee Prosthesis System

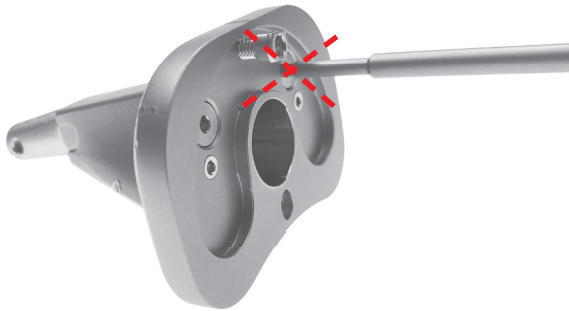
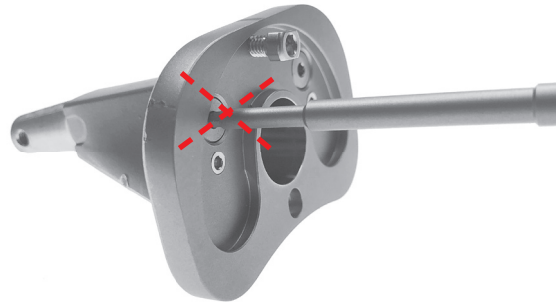
Endo-Model SL

If a Tilastan proximal spacer is to be used and either one or both blind screws of the modular tibial component cannot be loosened, then the following modified surgical technique is to be performed.

= screw removal impossible?

It has to be observed that a homogenous cement mantle between the Tilastan proximal spacer (full & half) and modular tibial component is ensured. The cement mantle should be 1-2 mm thick.

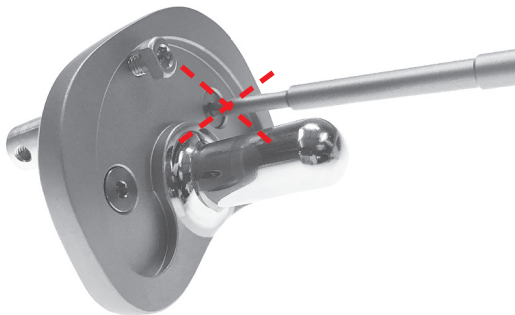
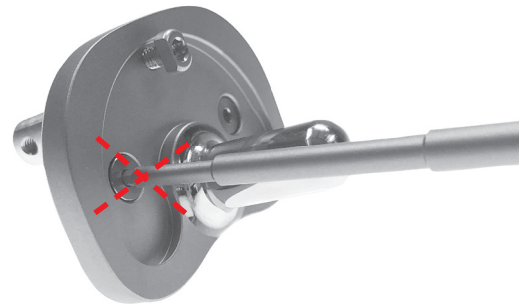
Endo-Model – M

If a Tilastan proximal spacer is to be used and either one or both blind screws of the modular tibial component cannot be loosened, then the following modified surgical technique is to be performed.

= screw removal impossible?

It has to be observed that a homogenous cement mantle between the Tilastan proximal spacer (full & half) and modular tibial component is ensured. The cement mantle should be 1-2 mm thick.
