Urgent Medical Device Field Action

MAR-18-2022 | REF-605552 | Rev A

Subject: VOLISTA paint chipping

Volista StandOp cupolas which has been manufactured until 31-Dec-2020.

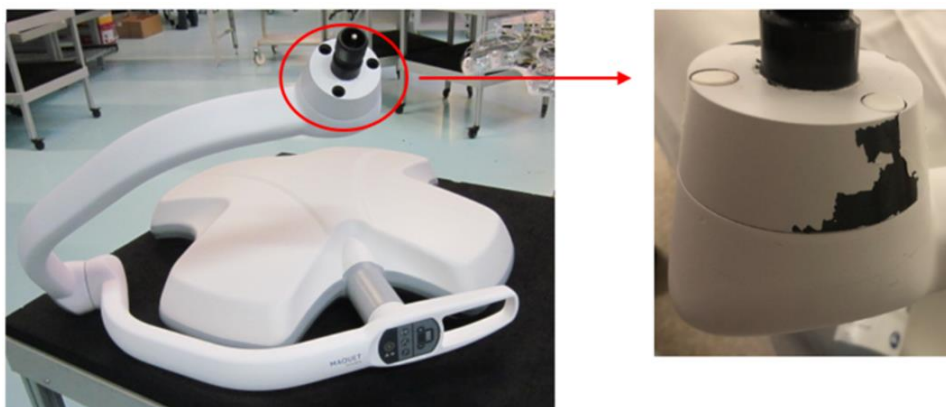
Under certain conditions, it was established that the paint could chip on a specific part of the fork. Therefore, there is a risk probability that paint particles may detached and fall in the operating field.

- The paint peeling is located on a specific part of the fork, as shown on the pictures below:

This issue may result at worst in a potential infection if particles fall during surgical operation in the patient body or in the operating field.

For remediating to this possible paint chipping, we require your contribution in paying attention to your device, and then if you experience the paint chipping on the affected part, to follow the instruction for our service support to replace the part with one with improved paint adhesion.

- Should you detect a paint peeling on this part of the fork, please evaluate if you should stop using your Volista and contact systematically your Getinge representative.

The Getinge Representative and our Service Support will proceed with the replacement in the shortest time-interval.
