17 December 2015

URGENT – FIELD SAFETY NOTICE

XEN•45 Glaucoma Treatment System (Lots 60815, 60869)

Increased actuation force on XEN Injector

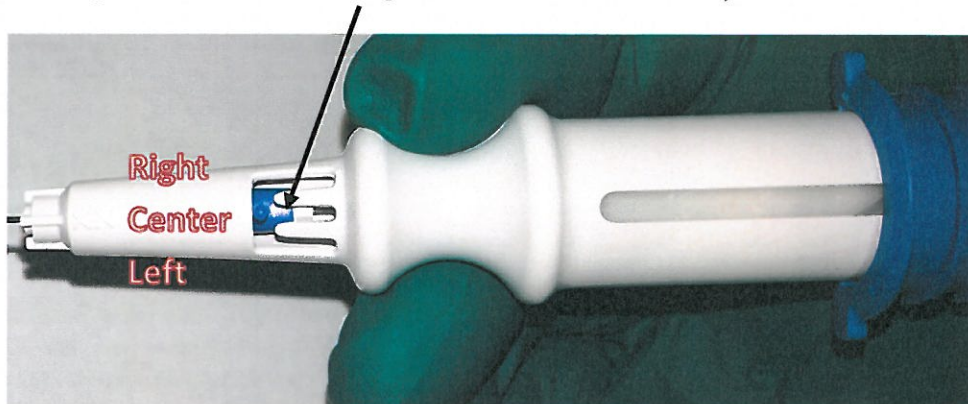
Figure 1: Needle bevel angle selector shown in center position

1. Follow the current instructions for use and remove the retention plug and the slider lock before inserting the injector into the eye.
2. Keep the needle of the injector tilted slightly upward to ensure the Gel Stent remains in the needle.
3. Verify that the needle bevel angle selector is in the **center position** (as shown in Figure 1).

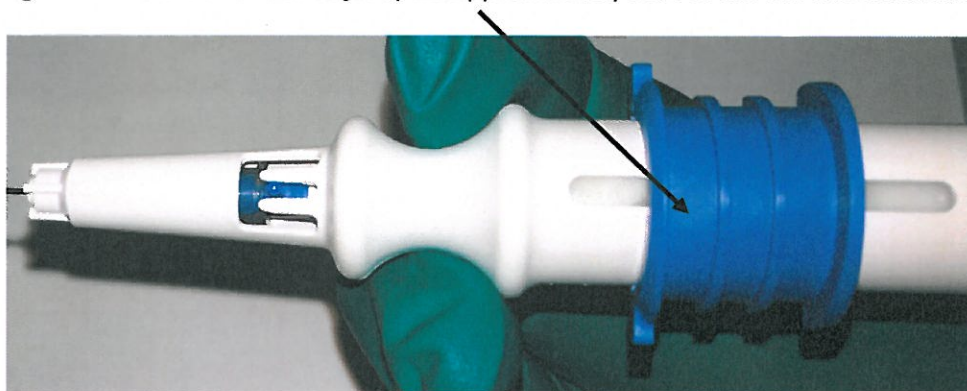
Figure 2: Slider advanced to just past approximately 75% of the full travel distance

4. Over a sterile tray or surface, carefully advance the slider forward to where the needle begins to retract (approximately 75% of the full travel distance as shown in Figure 2). The Gel Stent should advance but not fall out of the needle. Note: if the Gel Stent does fall onto the sterile tray, discard the system and use a new XEN system.

Note: As the surgeon moves the slider forward, the slider should run smoothly and without undue force. If the surgeon feels the slider force is unacceptable, **immediately stop the procedure** and prepare to use a new XEN system, repeating the steps above. Please return the discarded XEN unit to AqueSys (details below).
