Urgent Safety Information

Recommendation on the sterile removal of the primary cement powder bag PALACOS® and COPAL® bone cements

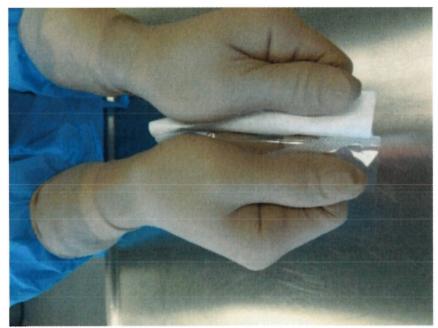
In individual cases, the secondary bag (polyethylene paper bag) of the bone cement products specified in the list may tear on opening, making sterile removal of the primary bag (cement powder bag) difficult. The reduced ability of the secondary bag to be torn open that is described here occurs due to the excessive tensile strength of the sealed seam. Given identical sealing parameters, the batches of packaging material affected exhibit higher tensile strength of the sealed seams, which all however conform with the applicable standards.

Photo: Recommended technique for tearing open the secondary bag

To further minimise the effect of reduced ability of the secondary bag to be torn open, we recommend that you grasp as much area of the piece of foil and paper as possible. As you do so, you should hold the paper/foil in the middle of the bag between your thumb and index/middle fingers.

Use the surface of the thumb down to the ball of the thumb and the finger surfaces (not the fingertips) to grasp the foil and paper (see photo).

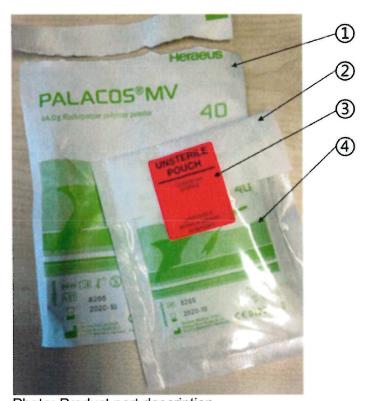
Photo: Product part description

No.	Name	Sterile
1	Aluminium bag	No
2	Secondary bag (polyethylene paper bag)	No
3	Unsterile label	No
4	Primary bag (cement powder bag)	Yes
