## URGENT FIELD SAFETY NOTICE

**Identifier:** FSCA NOVEMBER2017  
**Type of Action:** Re-inspection  
**Product:** Jarvik 2000 Ventricular Assist System, Adult VAD, Abdominal Cable Model, JHI-002  
**Subject:** Drive Cable Connector requires X-ray inspection to confirm presence of all three (3) connector pin crimps

### To: Distributors & Users of the Abdominal Driveline Jarvik JHI-002 VAD

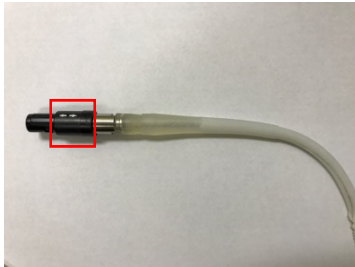
All drive cable connectors have three (3) wires inside each of three (3) pins, and each pin is required to be manually crimped by an operator during the assembly process. If one pin is not crimped, it is possible for the VAD to run normally so long as one of the three (3) wires inside

the pin makes electrical contact with the pin. However, if the drive cable is manipulated in such a way that **all** three (3) wires inside the pin do not make electrical contact with the pin, intermittent operation of the VAD or a pump stopped condition may occur.

Abdominal Drive Cable connector showing location of pin crimps

- all implanted patients have an X-ray inspection of their drive cable connector and images sent to Jarvik Heart, Inc. QA to review and confirm presence of pin crimps.
  - Jarvik Heart will provide a procedure for X-ray inspection of the connector
- all packaged JHI-002 VADs be quarantined until X-ray inspection of the drive cable connector can be performed by Jarvik Heart, Inc. to confirm presence of pin crimps.
