Urgent Field Safety Notice – FSN20213004-02 Rev 002

SynCardia Companion 2 (C2) Driver System (Catalog # 397002-001)

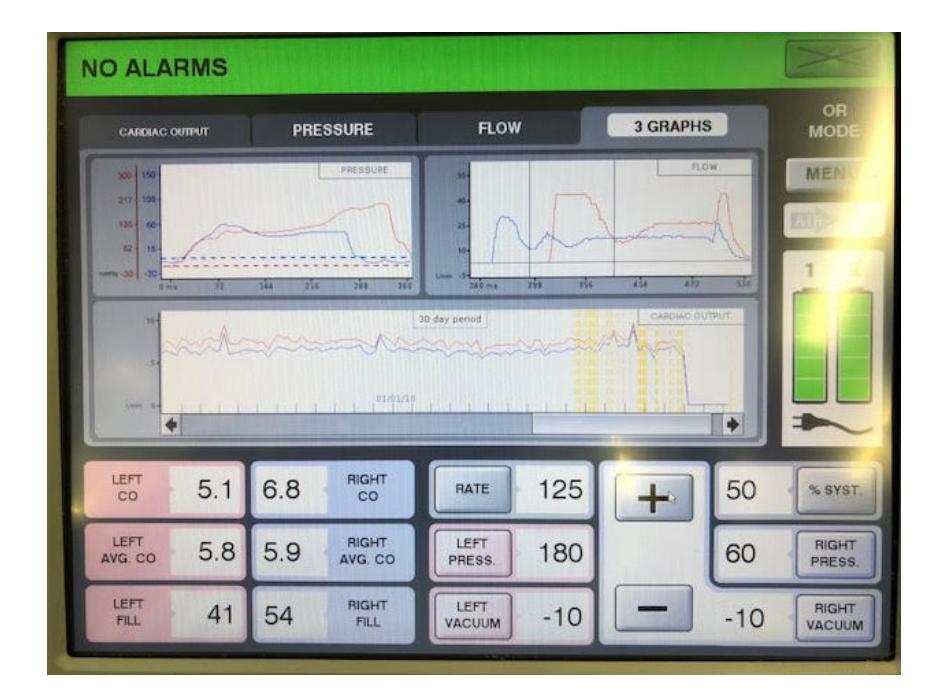
If an asynchronization of valve actuation between the C2 Driver's two pilot valves occurs, it will result in an activation timing difference between the valves. The timing issue will be observed on the C2 Driver Pressure and Flow monitor screens as a separation between the ventricles' systolic waveforms (Pressure Monitor Screen) and diastolic air flows at the beginning of the diastolic fill cycle (Flow

Monitor Screen). See **Figure 1** for an illustration of separated air flow waveforms at the beginning of a diastolic fill cycle.

Figure 1 – A waveform divergence between Pressure (Pressure Monitor Screen) and Air Flow (Flow Monitor Screen)

SynCardia has identified the root causes of the issue to be particulate contamination from the incoming air supply, and/or from the valve not completely closing due to residual electrical drop-off current applied to the valves when they are not activated.

A clinician/physician monitoring a patient on support with a C2 Driver should switch the patient to a backup driver **immediately** after observing:

- 1. A divergence between the Pressure waveforms and the Air Flow waveforms, as illustrated in **Figure 1**
- 2. An unexpected drop in cardiac output for one of the 2 ventricles,
- 3. "Low CO" alarm (Low cardiac Output)
- 4. A right/left cardiac output imbalance alarm.
