FIELD SAFETY CORRECTIVE ACTION

SUBJECT: **Bilox Delta Ceramic Head 28mm -3.5mm Neck (Catalogue No. 650-0830/Lot no. 3256398) mixed with Bilox Delta Ceramic Head 28mm Standard Neck (Catalogue No. 650-0831/Lot 3243206).**

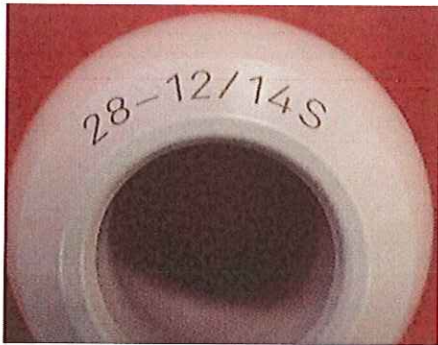
Biomet UK Ltd has initiated this action following an investigation that has revealed a product packaging labelled as **650-0830 Bilox Delta Ceramic Head 28mm - 3.5mm Neck Lot: 3256398** contains item **650-0831 Bilox Delta Ceramic Head 28mm Standard Neck Lot 3243206.**

**650-0830 item
is marked 28 -12/14 S**

1. Ensure all relevant Hospital staff are given relevant awareness training relating to this possible packaging error and are fully informed of the matter.

2. To assist us with this action, please ensure that the operating staff are made aware of this issue without delay and that all the affected implants are identified and withdrawn from use at your facility as soon as possible.

4. If you identify any item from the suspect item/ lot combinations, you will need to indicate the quantity you have available for return, the items then need to be returned to Biomet UK Ltd or to your local Biomet Distributor as soon as possible, you must ensure you complete the attached Fax-Back response form and return it to Biomet UK Ltd or to your local Biomet Distributor as soon as possible.

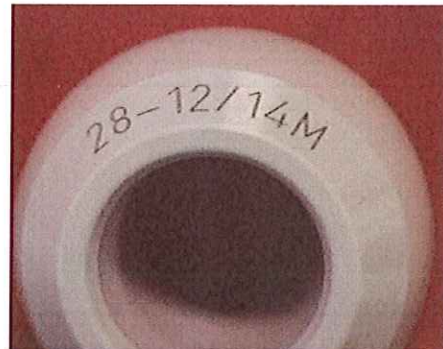
**650-0831 item
is marked 28 - 12/14 M**
