Subject: Important FIELD SAFETY NOTICE

**Information about a Field Safety Corrective Action for NIHON KOHDEN
Bedside Monitors series *Life Scope G9* (CSM-1901, CU-191RK, CU-192RK)
Software version 01-29
FSCA Ref. "FSCA-9150"**

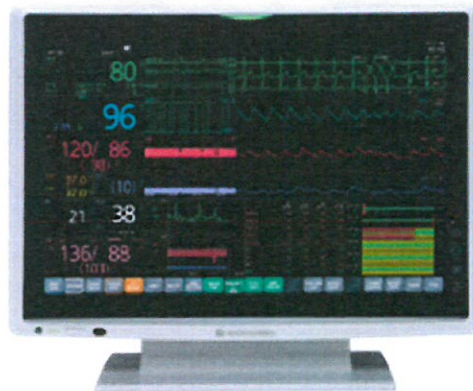
*Life Scope G9* (CSM-1901)

You get this FSN because you received at least one potential affected unit. Please consider that delivered non-affected units might have received a software upgrade later on and became affected after the software upgrade. The potential affected units can be identified by the model name and serial number which both are located on the product identification label at the backside of the Bedside Monitor *Life Scope G9* as well as the software version indicated in the software version window of the device.
