Ambu2021FA00001

Urgent Field Safety Notice

Ambu® SPUR® II for Demand Valve

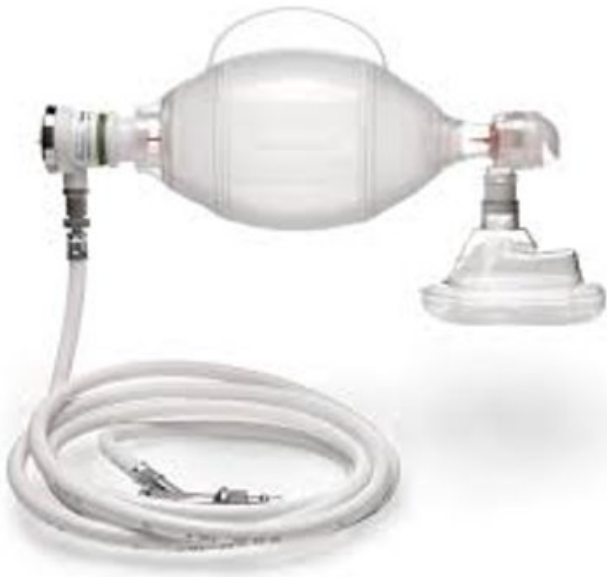
Ambu® SPUR® II for Demand Valve

Ambu has received an incident report following use of Ambu® SPUR II for demand valve from a German hospital, where the oxygen connector was found collapsed during use.

The oxygen connector on the Ambu SPUR II for demand valve can in very rare cases deteriorate during storage and present as collapsed. If a SPUR II for Demand Valve version with a collapsed oxygen connector is put into use, it will not be possible to provide the patient with additional oxygen from the oxygen reservoir. Additional oxygen can still be provided through the demand valve and ventilation with ambient air is still possible.

The traceability system at Ambu indicates that your institution has purchased the SPUR II for Demand Valve device produced between December 2014 and February 2019 and there may be affected devices in your stock. You should address this by discarding affected LOTs of the Ambu SPUR II for Demand Valve devices according to local regulations.
