## Urgent Field Safety Notice

BVM (Bag-Valve-Mask) Manual Resuscitation Systems

**FSCA-identifier:** 170124

**Date:** 05 June 2017

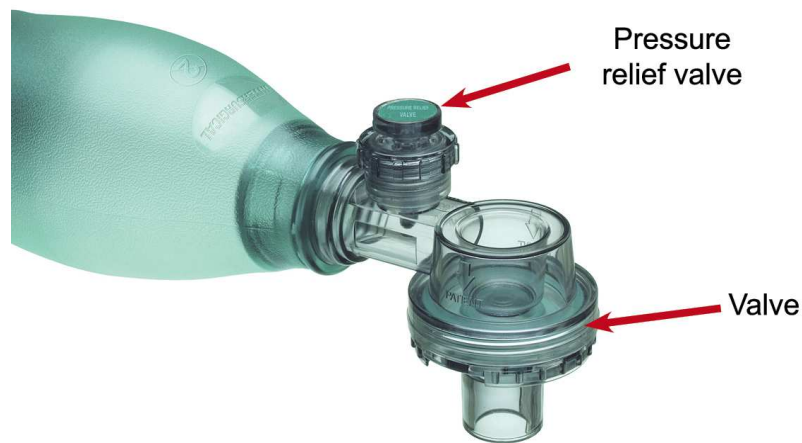
**Picture 1:** Position of valve and pressure relief valve if included in the system

1. Ensure the valve opens prior to use when squeezing the resuscitation bag (Picture 1).
2. If the valve is stuck (Picture 2), squeeze the bag fast and firmly to open the valve (Picture 3).
3. If the BVM Manual Resuscitation System contains a pressure relief valve (Picture 1) manually hold this closed to prevent it from opening when squeezing the bag. Repeat action 2 whilst the pressure relief valve function is overridden.
4. Make sure the valve is now open and fully functional prior to use.
